**Flood Control Project Maintenance
Levee Inspections**
LMA District Cover Sheet
Spring 2017 Levee Inspection Results

Merced Streams Group

**Flood Control Project Maintenance
Levee Inspections
Unit Cover Sheet
Spring 2017 Levee Inspection Results
Merced Streams Group**

| Waterway | | | Bank | Unit Miles |
|--|---|---|---|---|
| Unit No. 01 Black Rascal Diversion | | | Right | 1.61 |

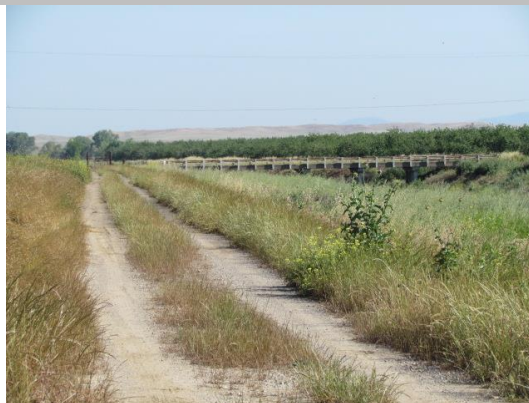
Photo 1 of 1 : SP_2017_NA0013_331_7_20170502_00006.jpg

Looking back upstream at the weed growth on the crown roadway.

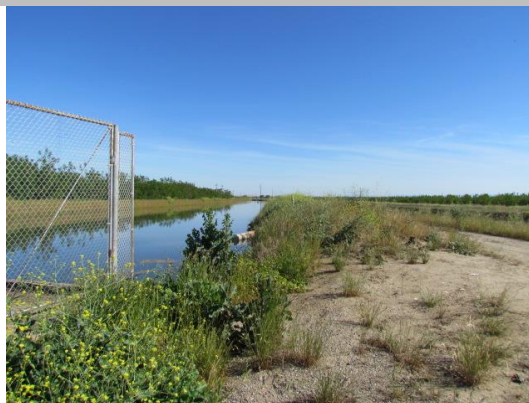
Photo 1 of 1 : SP_2017_NA0013_331_2_20170502_00005.jpg

Standing on the landside at levee mile 0.01 looking back upstream at the unsatisfactory weed growth.

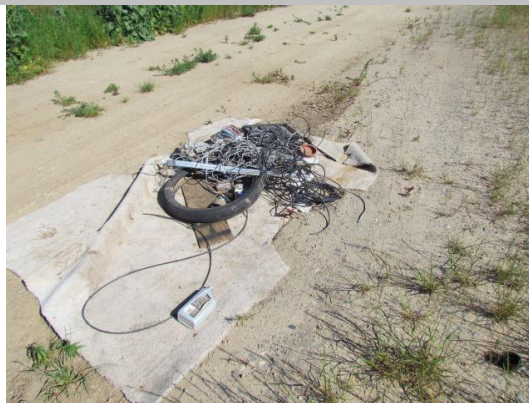
Photo 1 of 1 : SP_2017_NA0013_331_3_20170502_00009.jpg

Garbage placed on the crown roadway.

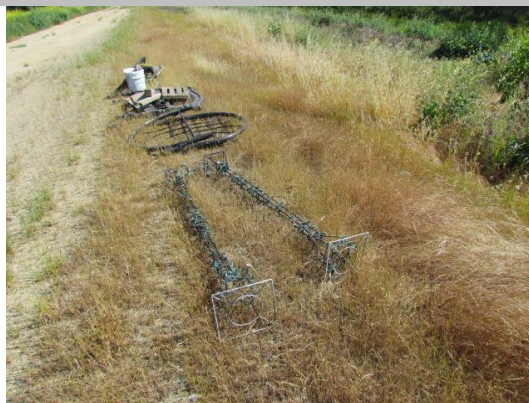
Photo 1 of 1 : SP_2017_NA0013_331_12_20170502_00008.jpg

Debris and house hole garbage dumped on the waterside levee shoulder.

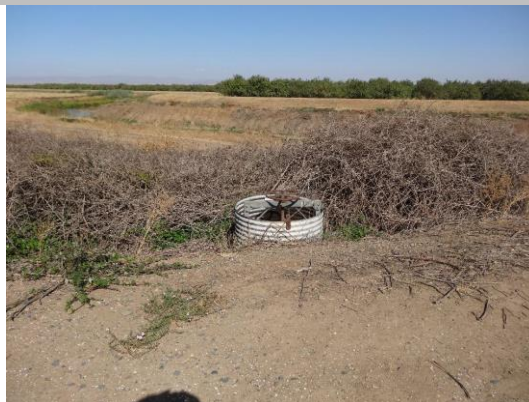
Photo 2 of 3 : UCIP_SP_2017_41672_35210.jpg

LS view: overview of CM pipe riser with slide gate. Dense vegetation on landside.

| UCIP Comments: Verify Pipe is abandoned or still intact.- may be this crossing was abandoned/removed during recent levee reconstruction.- no signs of pipe and appurtenances on waterside.- only a CM pipe riser with slide gate found on landside. | | | | | | |

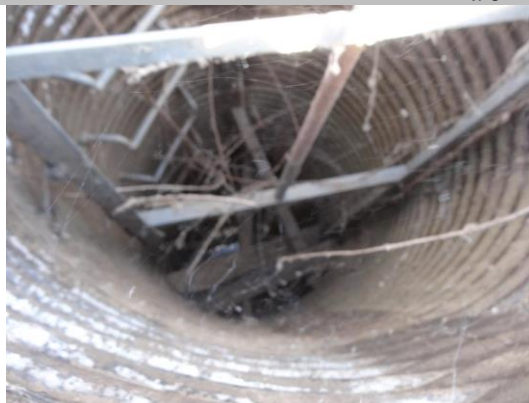
Photo 3 of 3 : UCIP_SP_2017_41672_35209.jpg

LS view: inside view of CM pipe riser with slide gate.

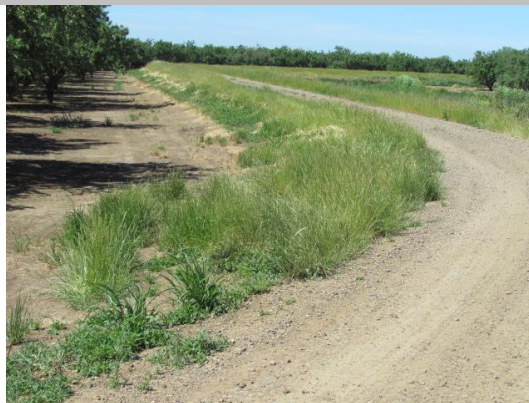
Photo 1 of 1 : SP_2017_NA0013_332_11_20170502_00031.jpg

Looking downstream from levee mile 0.00 unwanted tall weeds on the landside slope and shoulder.

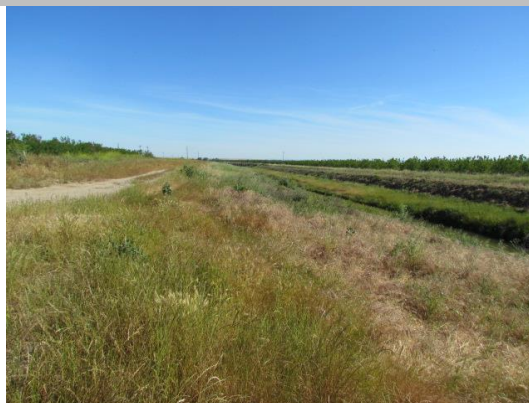
Photo 1 of 1 : SP_2017_NA0013_332_12_20170510_00034.jpg

Looking upstream from the waterside levee slope Black Rascal Diversion Canal, tall unwanted weeds present along the levee slope and shoulder.

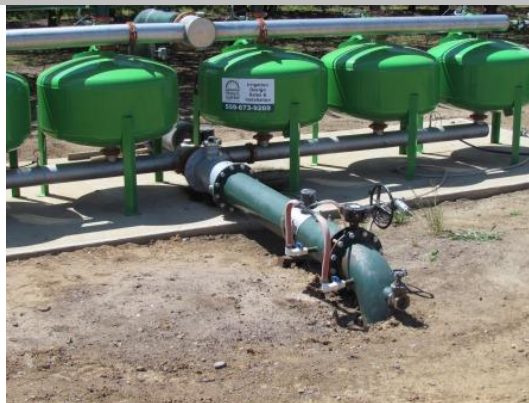
Photo 1 of 3 : SP_2017_NA0013_332_2_20170404_00001.jpg

There is no CVFPB permit on file for this installation. Photo taken 4-23-2014

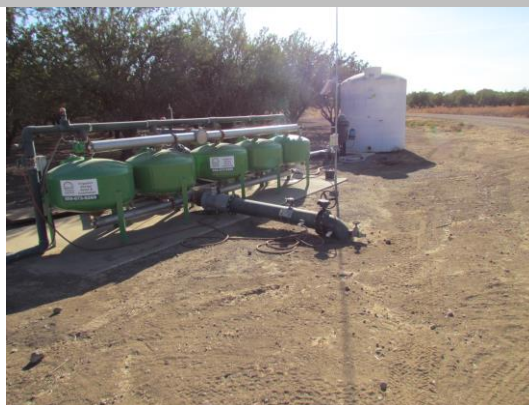
Photo 2 of 3 : SP_2017_NA0013_332_2_20170404_00002.jpg

No Permit for this filtration system and tank on the easement. 2016

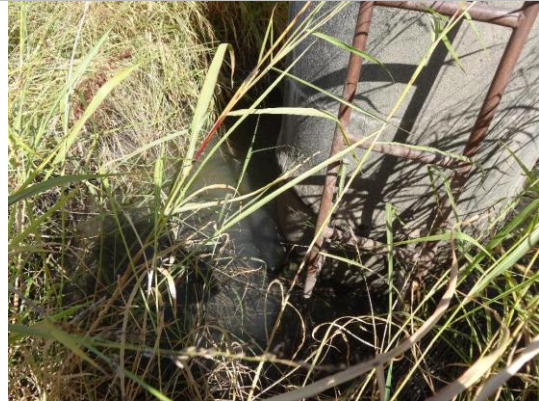
Photo 3 of 3 : UCIP_SP_2017_21263_35764.jpg

WS view: concrete standpipe with water ponding at its base.

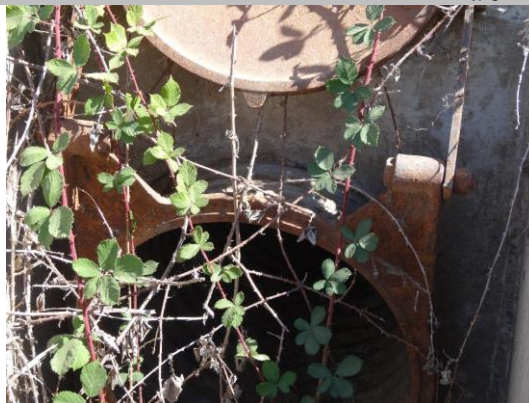
Photo 2 of 3 : UCIP_SP_2017_50156_35244.jpg

WS view: U typed concrete headwall, CM pipe, and flap gate. Flap gate was not closed. Vegetation needs to be cleared.

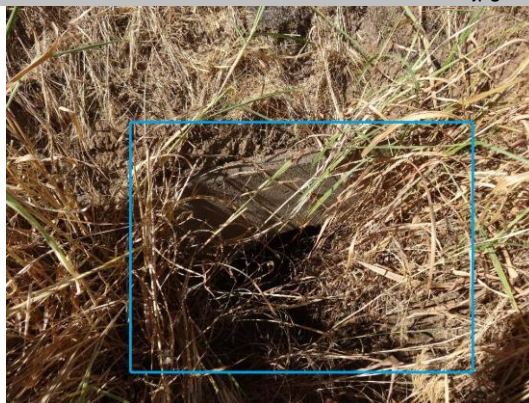
Photo 3 of 3 : UCIP_SP_2017_50156_35246.jpg

LS view: concrete headwall and CM pipe. Inlet needs cleaning.

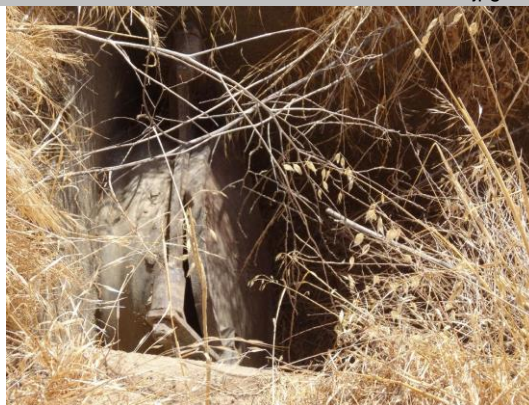
Photo 2 of 3 : UCIP_SP_2017_20946_35265.jpg

WS view: U typed concrete headwall, CM pipe, and flap gate. Flap gate was not properly closed.

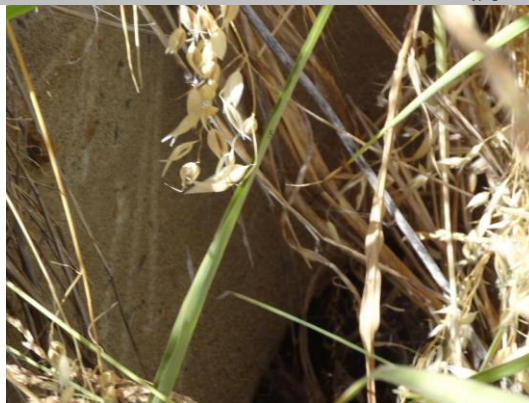
Photo 3 of 3 : UCIP_SP_2017_20946_35264.jpg

LS view: concrete headwall and CM pipe. Inlet needs cleaning.

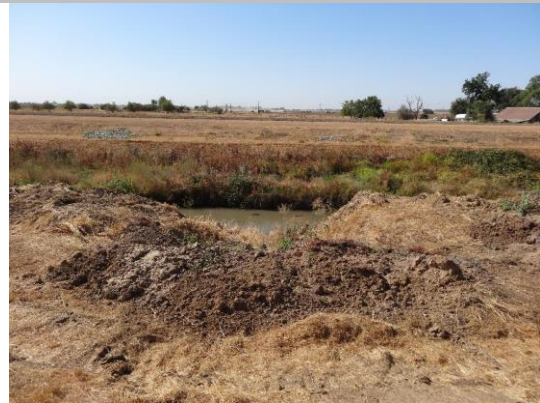
Photo 1 of 3 : UCIP_SP_2017_20992_35370.jpg

| FS_ID:20992 DS_ID:23055 EP_NO: N/A Repair Type: Non-Urgent Crossing Status: Found UCIP Comments: - mud and debris from recent channel cleaning needs to be removed from spillway and outlet - pipe filled with debris, it needs cleaning.- half of inlet pipe buried. FIELD_STRUCT_DESC: 24-inch corrugated metal drainage pipe through the levee, 8.0 feet below the crown, concrete headwall, flap gate, and concrete grouted cobble spillway on the waterward toe, concrete headwall on the landward toe (O&M Unit No. 607, 1962) FS Date: 9/17/2013 | | | | | |

WS view: concrete headwall and CM pipe buried under debris and mud.

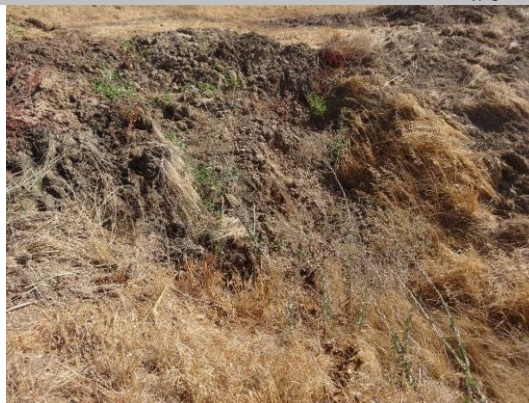
Photo 2 of 3 : UCIP_SP_2017_20992_35369.jpg

WS view: debris and mud deposited from the channel cleaning. It needs to be cleared from spillway and outlet structure.

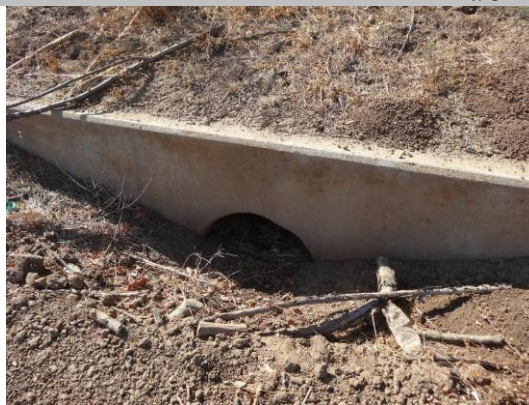
Photo 3 of 3 : UCIP_SP_2017_20992_35366.jpg

LS view: concrete headwall and CM pipe. Half of intet pipe burried.

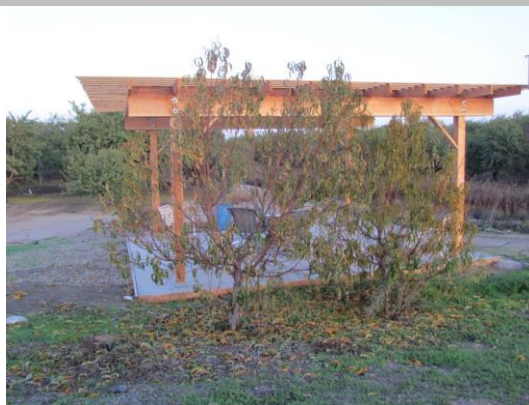
Photo 2 of 4 : SP_2017_NA0013_332_24_20170404_00005.jpg

Another view of unauthorized structure.

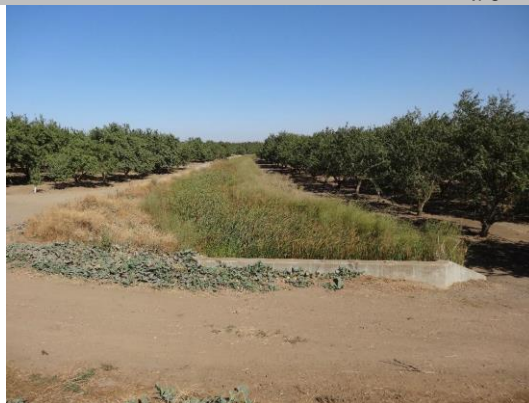
Photo 2 of 3 : UCIP_SP_2017_20965_35291.jpg

LS view: headwall on levee toe. Green vegetation in drainage channel.

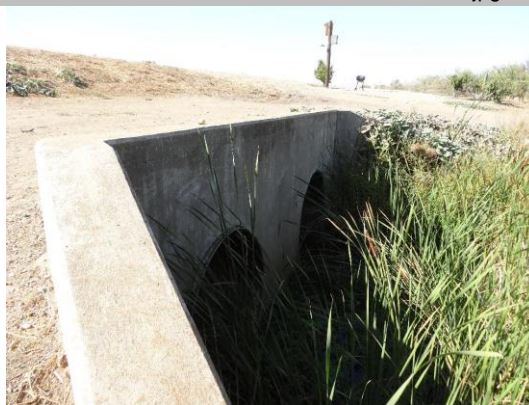
Photo 3 of 3 : UCIP_SP_2017_20965_35290.jpg

LS view: two CM pipes and U typed headwall on levee toe. Green vegetation in drainage channel.

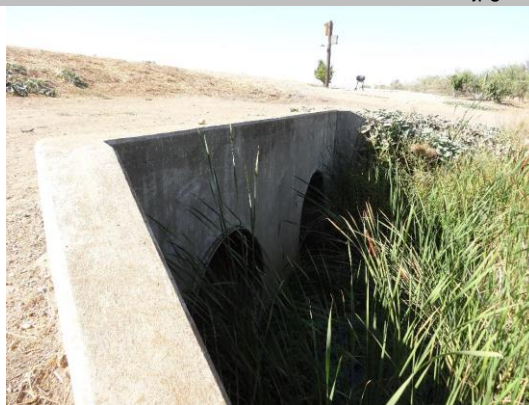
Photo 2 of 3 : UCIP_SP_2017_20983_35301.jpg

LS view: U typed concrete headwall, two CMPs in drainage ditch. Dense vegetation in drainage ditch.

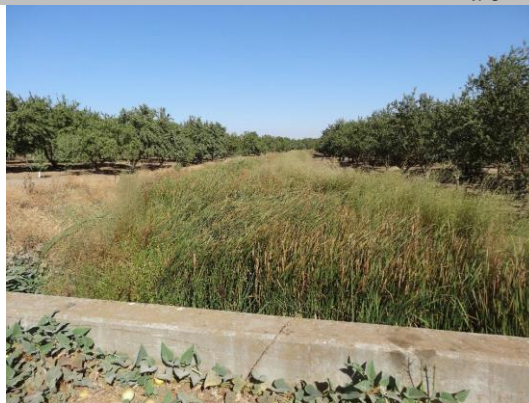
Photo 3 of 3 : UCIP_SP_2017_20983_35300.jpg

LS view: concrete headwall in drainage ditch. Dense vegetation in drainage ditch.

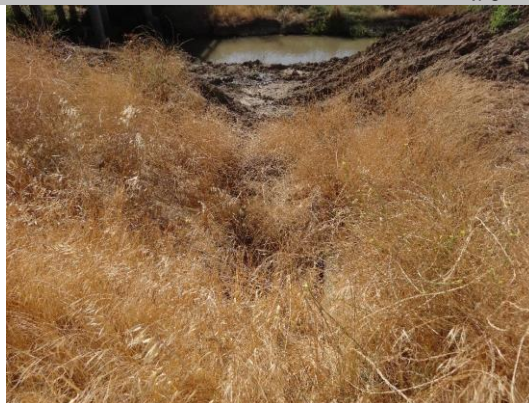
Photo 1 of 3 : UCIP_SP_2017_42993_35310.jpg

WS view: overview of outlet area and channel. Debris and vegetations on spillway.

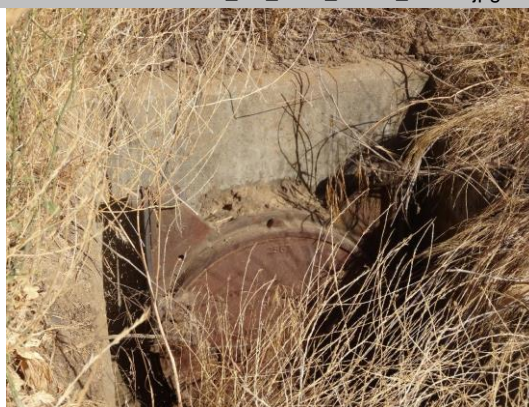
Photo 2 of 3 : UCIP_SP_2017_42993_35309.jpg

WS view: U typed concrete headwall, CM pipe and flap gate. Vegetation and debris need to be cleared.

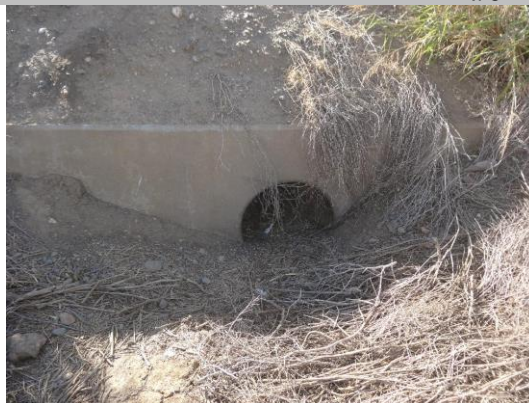
Photo 3 of 3 : UCIP_SP_2017_42993_35312.jpg

LS view: concrete headwall and CM pipe. Inlet needs cleaning. Part of inlet pipe buried.

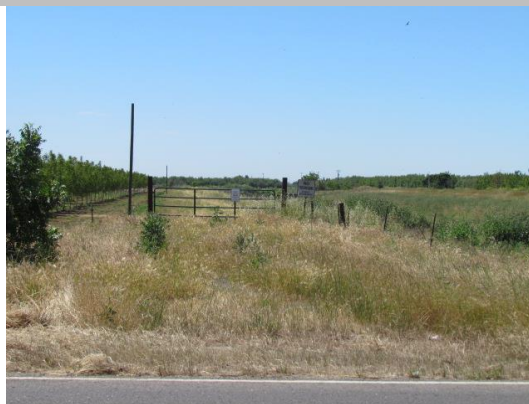
Photo 1 of 1 : SP_2017_NA0013_332_17_20170510_00036.jpg

Looking downstream from levee mile 1.62 to 1.85 crown roadway completely overgrown with vegetation.

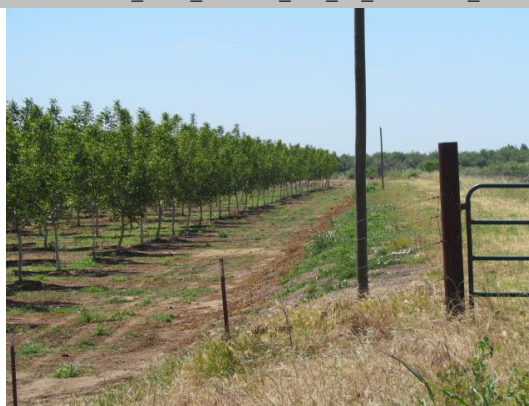
Photo 1 of 1 : SP_2017_NA0013_332_18_20170510_00037.jpg

Looking downstream from levee mile 1.63 landside slope and shoulder covered with wild weeds. To levee mile 1.85.

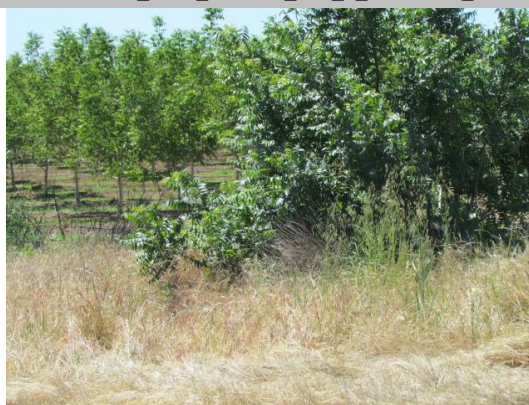
Photo 1 of 1 : SP_2017_NA0013_332_9_20170502_00033.jpg

Unwanted nut tree on the landside shoulder levee mile 1.63.

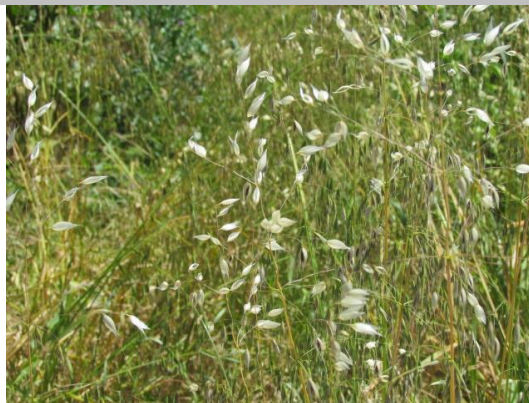
Photo 1 of 1 : SP_2017_NA0013_333_13_20170519_00023.jpg

Owens Creek looking upstream from levee mile 0.00, wild weeds has completely blocked the view of the levee section.

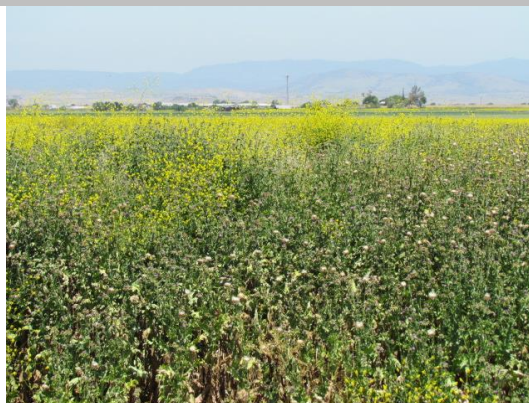
Photo 1 of 1 : SP_2017_NA0013_333_12_20170519_00025.jpg

Owens Creek levee mile 0.00 -1.40, unsatisfactory growth of weeds has completely taken over the levee section.

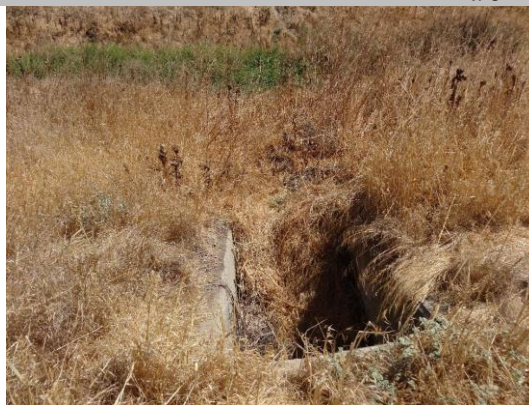
Photo 2 of 3 : UCIP_SP_2017_41815_35532.jpg

WS view: Silt needs to be removed. Vegetations needs to be cleared.

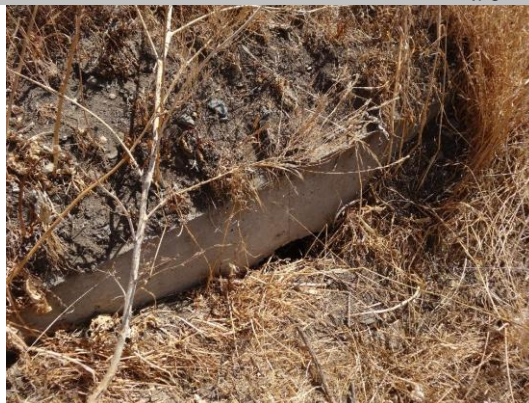
Photo 3 of 3 : UCIP_SP_2017_41815_35531.jpg

LS view: concrete headwall and CM pipe. Inlet needs cleaning and silt removed.

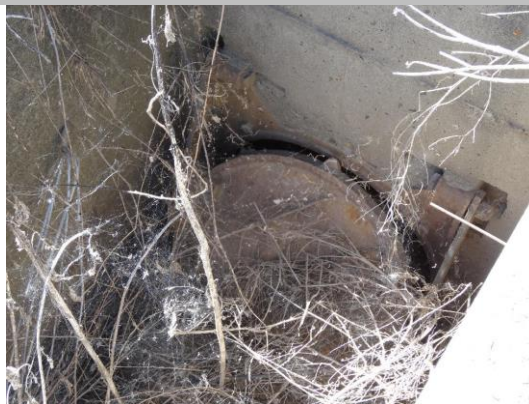
Photo 2 of 3 : UCIP_SP_2017_50144_35421.jpg

WS view: U typed concrete headwall, CM pipe, and flap gate. Damaged flap gate.

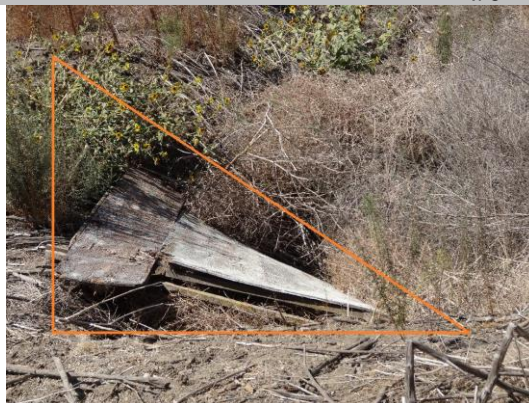
Photo 3 of 3 : UCIP_SP_2017_50144_35420.jpg

LS view: Debris dumped on onlet structure. Needs to be cleared or abandoned properly.

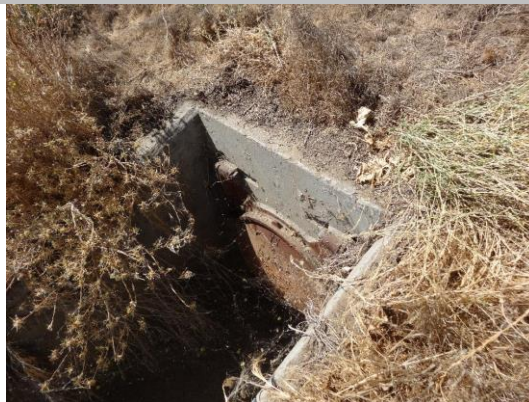
Photo 2 of 3 : UCIP_SP_2017_50149_35534.jpg

WS view: U typed concrete headwall, CM pipe, and flap gate. Vegetation needs to be cleared.

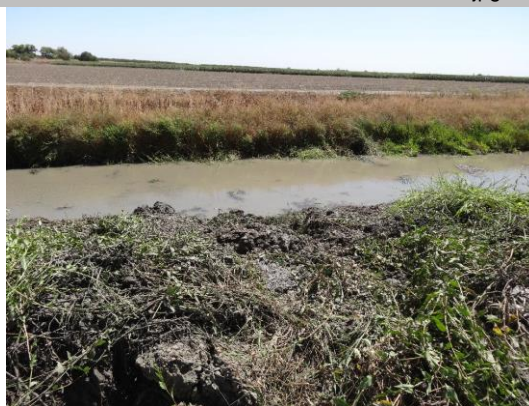
Photo 1 of 3 : UCIP_SP_2017_21063_35502.jpg

WS view: U typed concrete headwall, CM pipe, and flap gate buried under mud/debris.

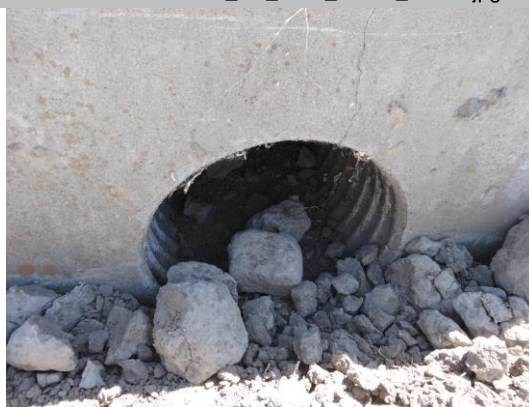
Photo 3 of 3 : UCIP_SP_2017_21063_35500.jpg

LS view: closer view of CM pipe. Inlet needs cleaning & clearing.

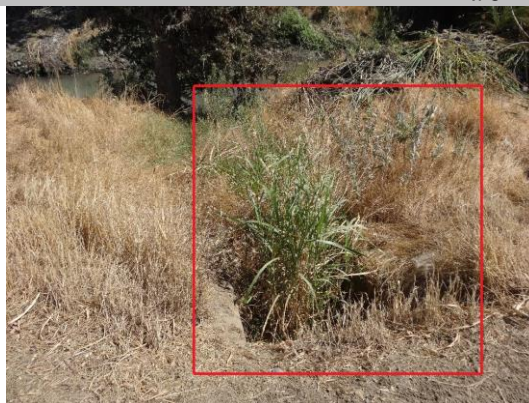
Photo 1 of 3 : UCIP_SP_2017_21064_35506.jpg

WS view: cobble spillway and channel on waterside. Dense vegetation on levee slope and spillway.

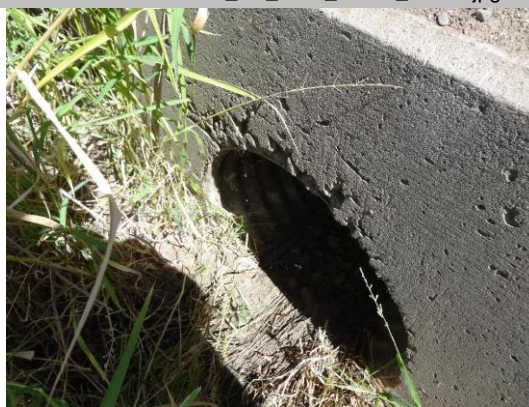
Photo 3 of 3 : UCIP_SP_2017_21064_35504.jpg

LS view: concrete headwall and CM pipe. Inlet needs clearing.

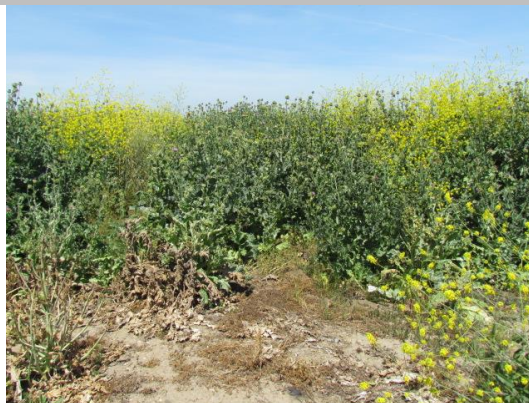
Photo 2 of 2 : SP_2017_NA0013_334_13_20170519_00031.jpg

Owens Creek Unit 4 looking upstream from levee mile 1.41, the weeds are taller than 8.0 foot.

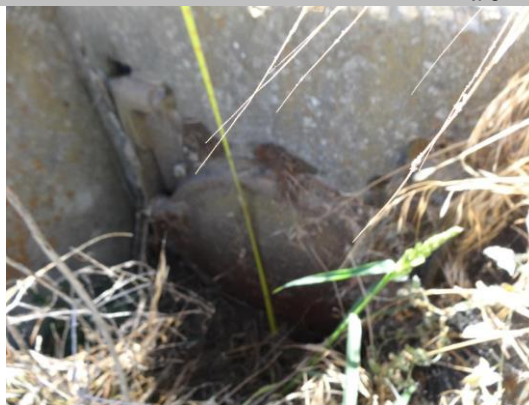
Photo 2 of 3 : UCIP_SP_2017_42991_35750.jpg

WS view: U typed concrete headwall, CM pipe, and flap gate. Vegetation and silt need to be cleared.

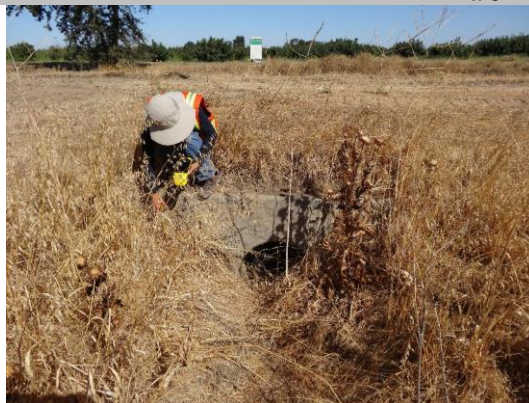
Photo 3 of 3 : UCIP_SP_2017_42991_35749.jpg

LS view: concrete headwall and CM pipe. Inlet silt needs clearing.

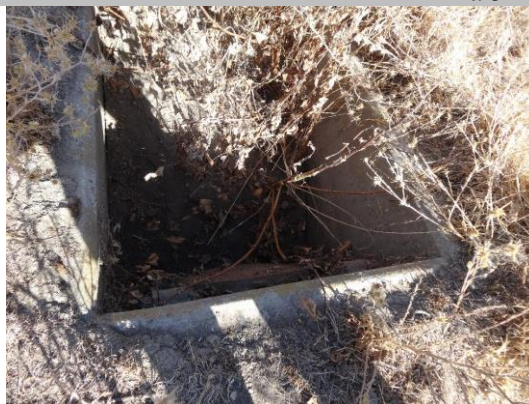
Photo 1 of 3 : UCIP_SP_2017_50146_35748.jpg

WS view: U typed concrete headwall, CM pipe, and flap gate. Vegetation needs to be cleared.

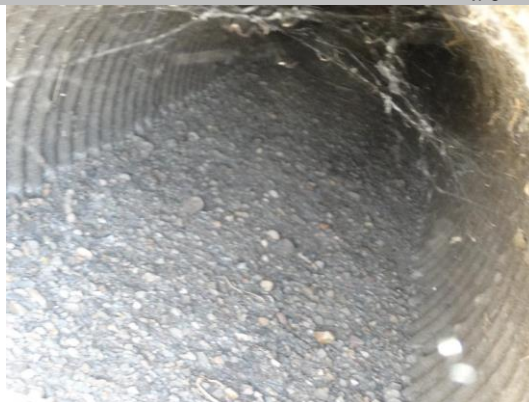
Photo 3 of 3 : UCIP_SP_2017_50146_35746.jpg

LS view: inside view of CM pipe. Inlet pipe needs clearing.

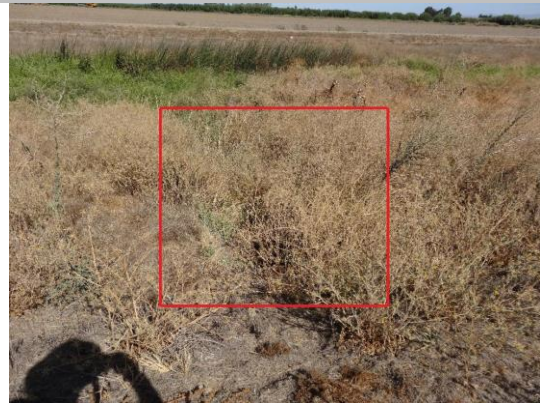
Photo 1 of 3 : UCIP_SP_2017_50154_35608.jpg

WS view: Dense vegetation on levee slope and spillway.

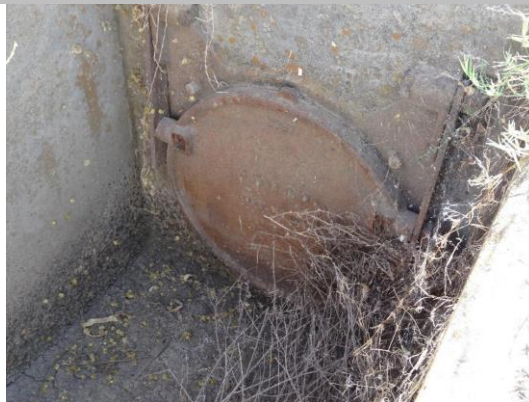
Photo 3 of 3 : UCIP_SP_2017_50154_35606.jpg

WS view: CM pipe and flap gate. Vegetation needs to be cleared.

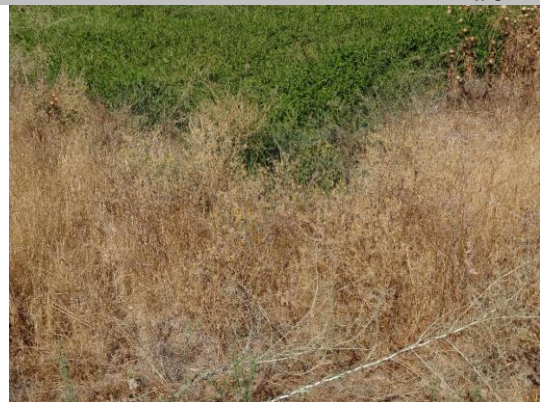
Photo 1 of 3 : UCIP_SP_2017_50155_35642.jpg

WS view: Dense vegetation on levee slope and spillway.

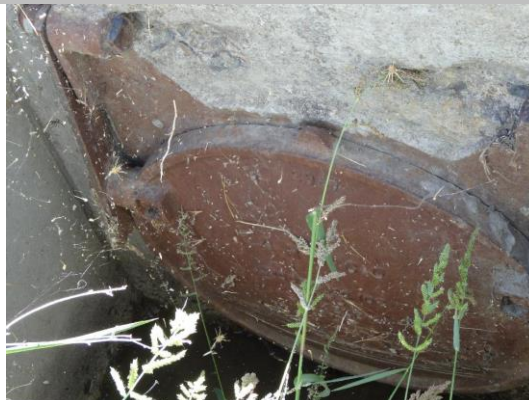
Photo 3 of 3 : UCIP_SP_2017_50155_35640.jpg

WS view: CM pipe and flap gate. Vegetation needs to be cleared.

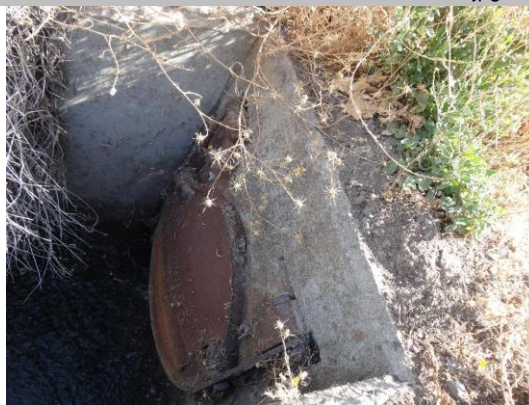
Photo 2 of 3 : UCIP_SP_2017_21126_35651.jpg

WS view: U typed concrete headwall, CM pipe, and flap gate. Vegetation needs to be cleared on spillway.

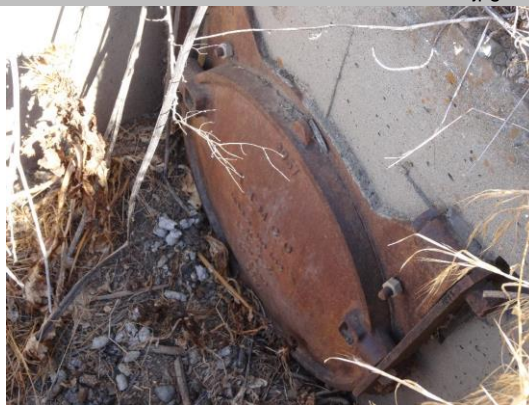
Photo 2 of 3 : UCIP_SP_2017_21210_35708.jpg

WS view: U typed concrete headwall, CM pipe, and flap gate. Spillway needs to be cleared.

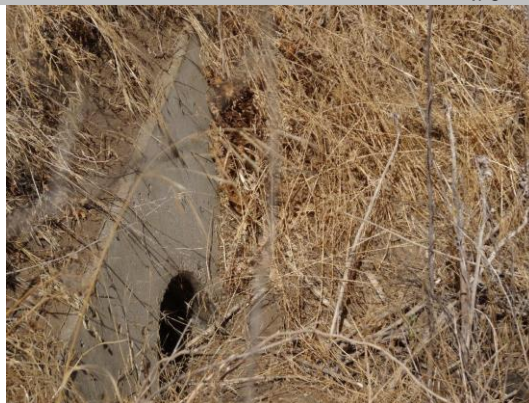
Photo 3 of 3 : UCIP_SP_2017_21210_35707.jpg

LS view: concrete headwall and CM pipe. Inlet silt needs clearing.

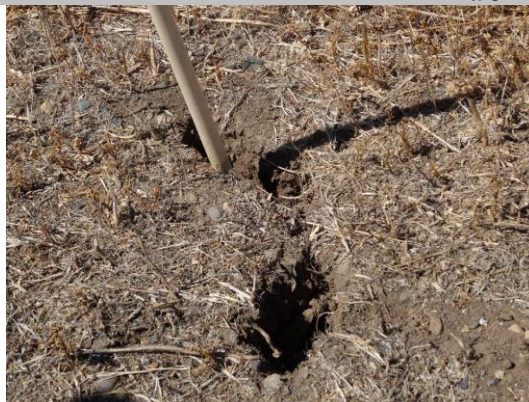
Photo 2 of 3 : UCIP_SP_2017_50153_35744.jpg

WS view: significant levee cracks along the pipealignment. Needs detailed investigation on the issue.

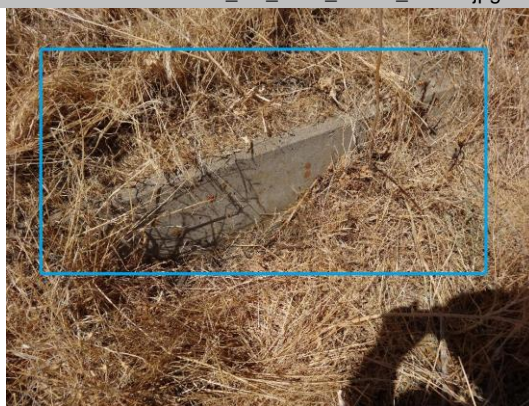
Photo 3 of 3 : UCIP_SP_2017_50153_35743.jpg

LS view: concrete headwall and buried CM pipe. Dirt removal and clearing needed in inlet.
